Paper Number: 072203

Channel Stabilization, Habitat Restoration, and Realignment Feasibility Study for Class I Trout Stream in Wisconsin

**Deni Hazell, Agricultural Engineer
Barb Lensch, State Geologist
Mary King, Area Engineer
USDA Natural Resources Conservation Service
Wisconsin**

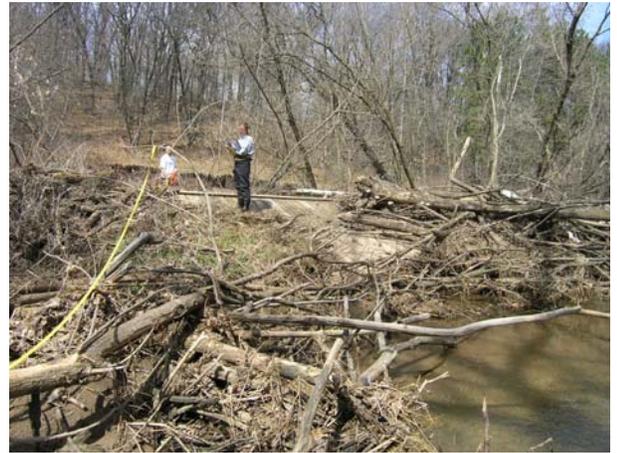
It is believed that a wooden bridge installed by a local snowmobile association aggravated the stream's erosion problems when it washed downstream, got stuck, and blocked water flow. Our restoration work includes the removal of this bridge.

Figure 5. Wooden snowmobile bridge washed down, blocking stream flow downstream of eroding site.

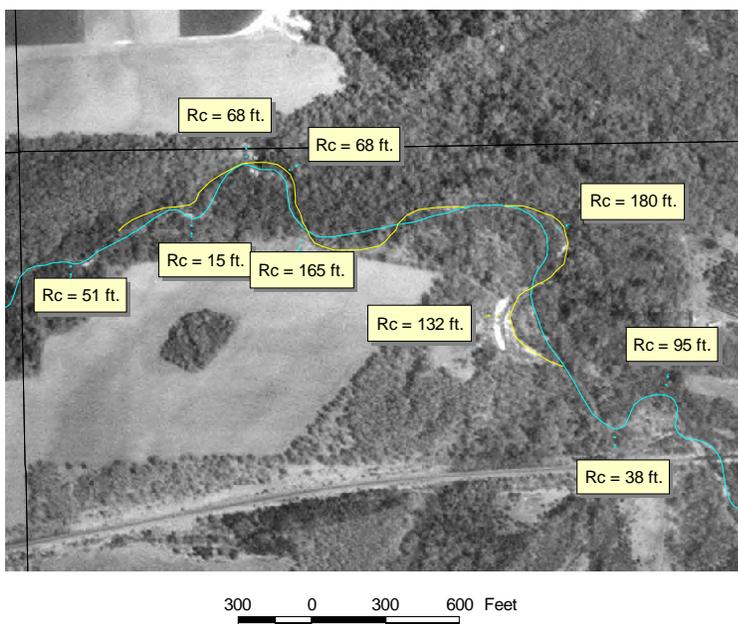
The yellow line in the photo below is the approximate creek location in 1992 whereas the line in blue is from the topographic map which was dated 1972. In 20 years, the increase in sinuosity can be seen. The site where work was initially done is the curve with the radius of curvature of 165 feet. The maximum distance the creek has moved at the site in the 20 years from 1972 to 1992 is 67 feet for an average annual rate of movement of the creek of 3.3 feet. The sinuosity of the creek has changed from 1.3 in 1972 to 1.4 in 1992 with a total increase in length from (the curve labeled $R_C = 51$ ft. downstream to the railroad tracks) of 300 feet!

Due to the thick sequences of layered sands and gravels in the creek and river valleys in addition to poor land use in the past, there is excess sediment in the system. Excess sediment from the eroding banks is too great to be transported by the stream so the stream drops much of its load and creates multiple channels at the downstream end of the site.

Figure 6. Change in sinuosity of the stream

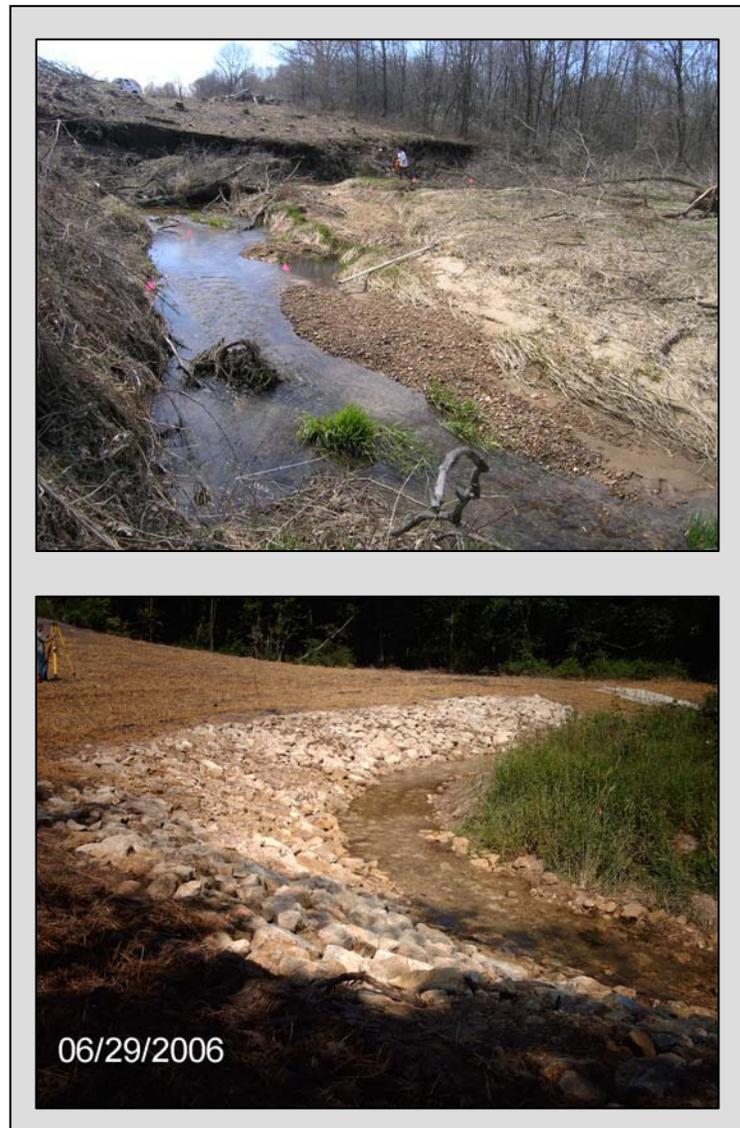
Figure 9. Before construction (top) and narrowing and re-routing of the stream (bottom) in Downstream Riprap location (looking upstream).

To improve trout habitat we planned on reducing sedimentation in the stream. In order to accomplish this, we looked at other segments of the stream that appeared to be stable and attempted to narrow the stream in our work area to a width typical to that in the healthier areas of the stream (about 6 feet wide). This would maintain a constantly higher velocity throughout the channel, thus reducing sediment accumulation at the bottom.

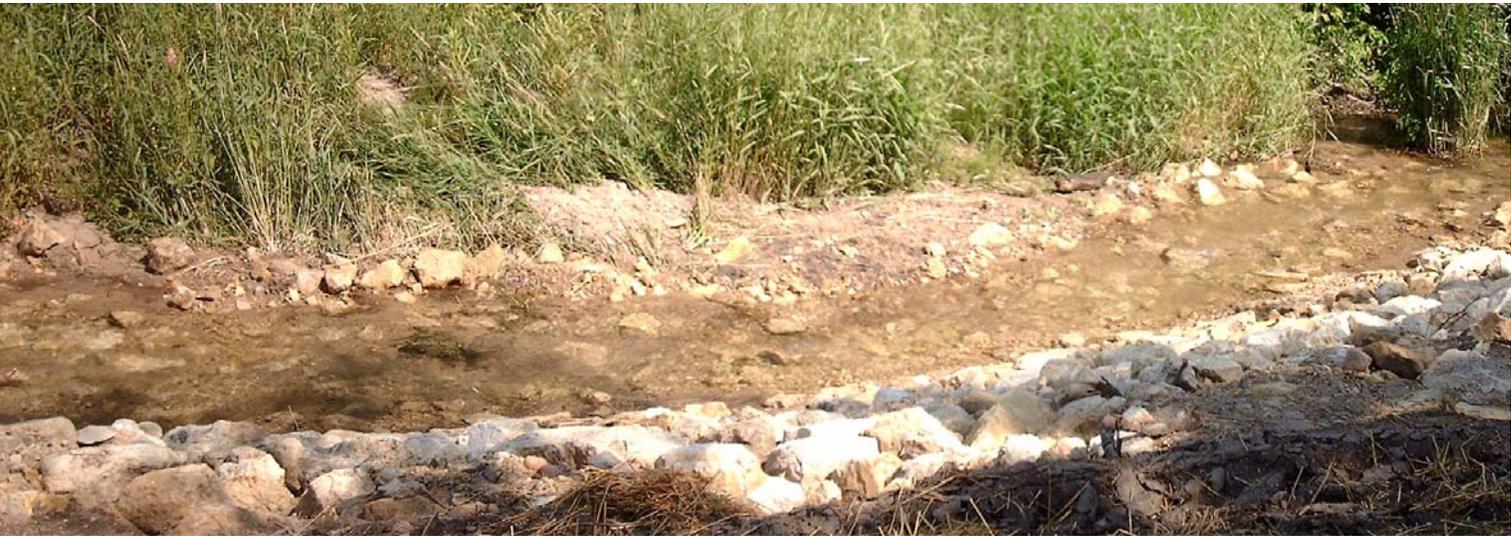
Figure 12. Prior to construction, sediment accumulation along the channel bottom was one of the greatest concerns that threatened trout population in this stream.

earthwork is evident along channel bottom.

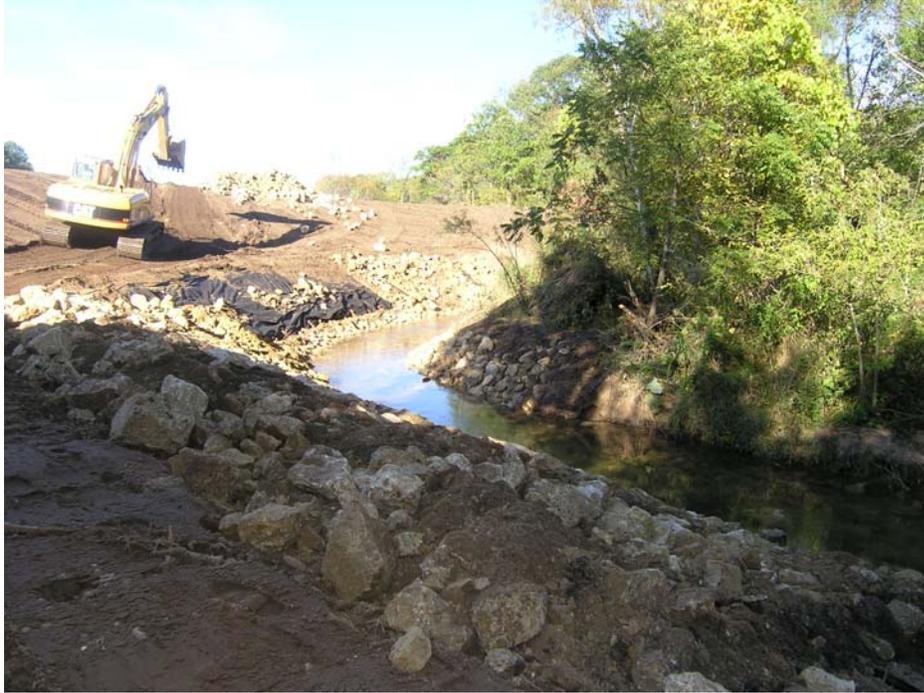
Figure 31. looking upstream on East streambank site during construction.

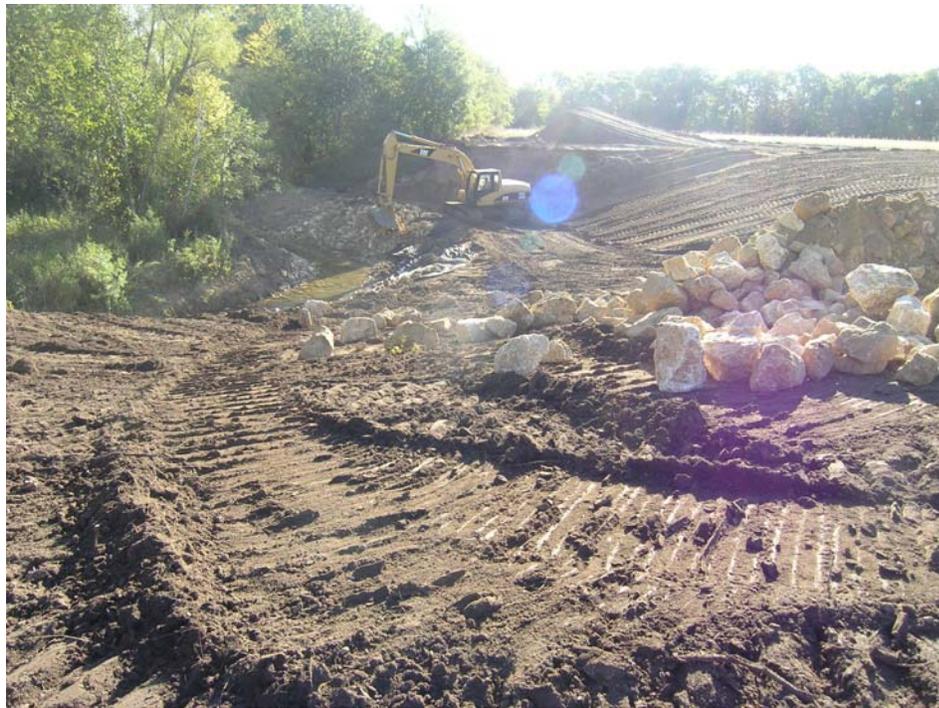
Figure 32. looking downstream on East streambank site during construction

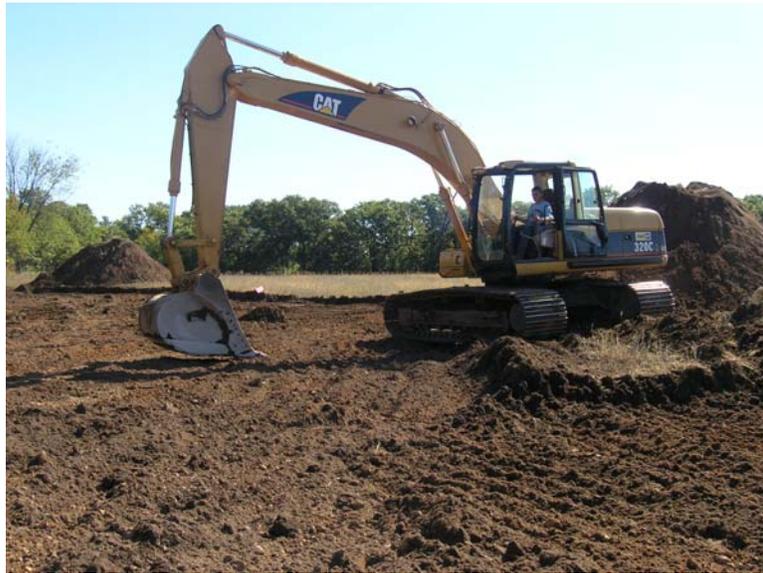
Figure 33. Soil stripping and site preparation.

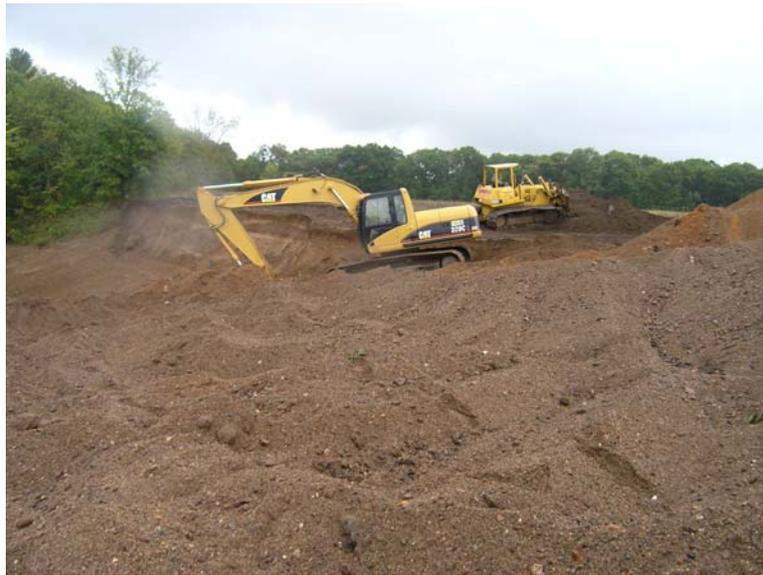
Figure 34. Sloping of bank.

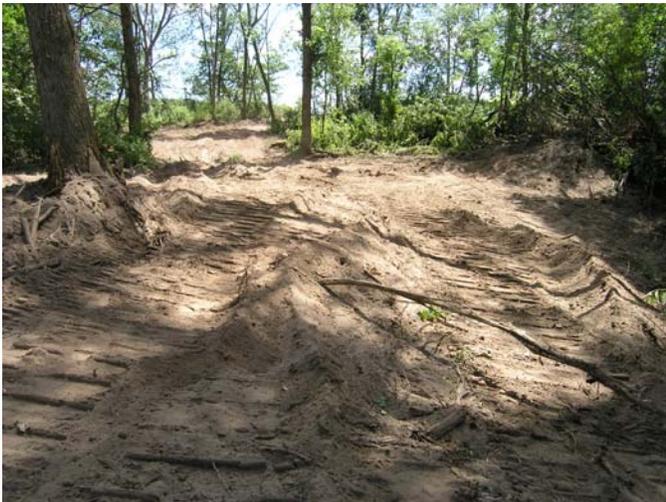
Figure 41. Cleared access to washed snowmobile bridge.

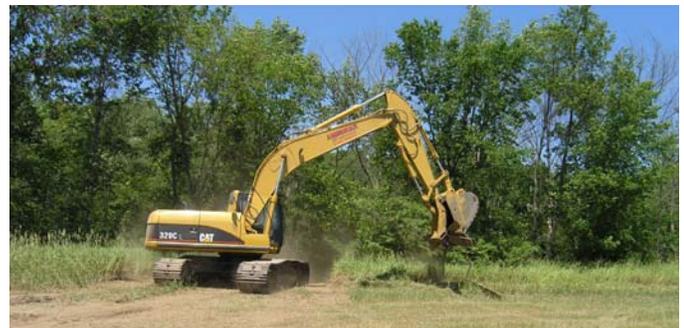
Figure 42. Bridge removal.

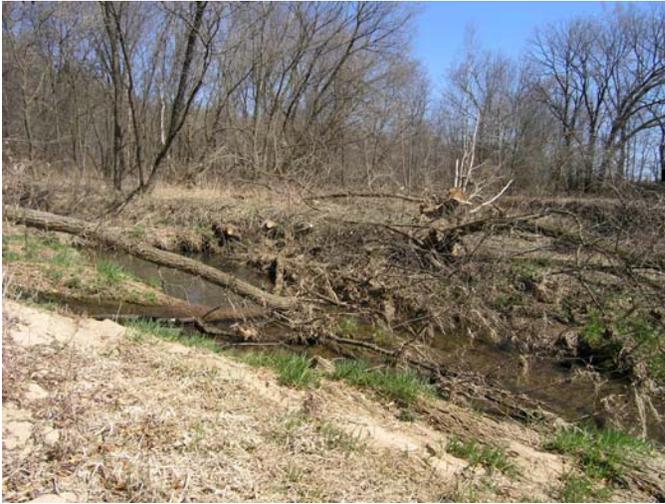
Figure 47. West streambank site prior to construction start.

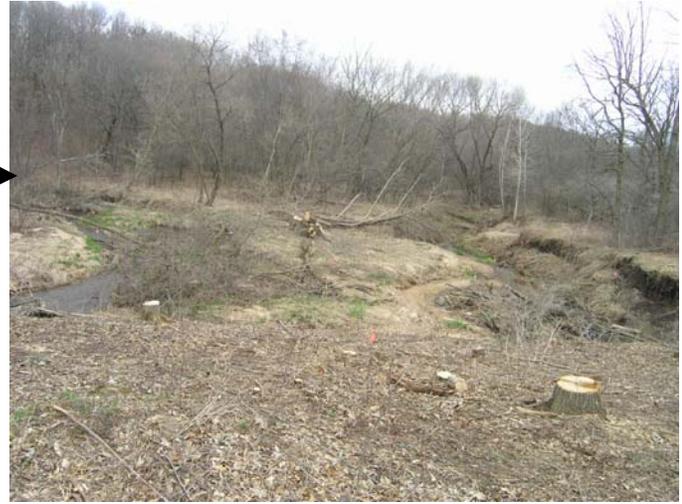
Figure 48. West streambank site after clearing of trees.

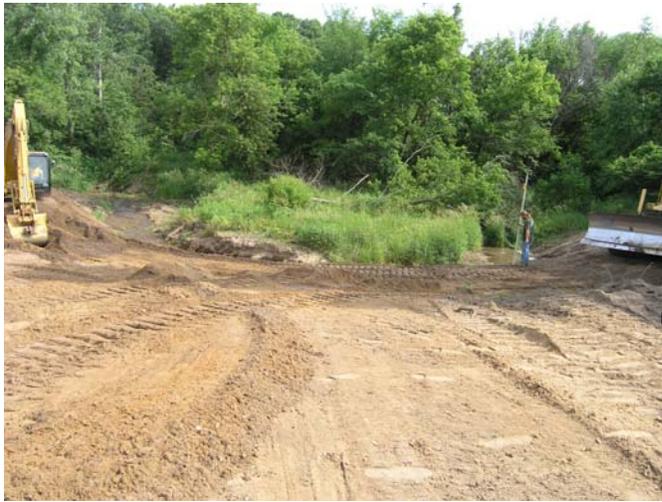
Figure 49 West streambank site during construction.

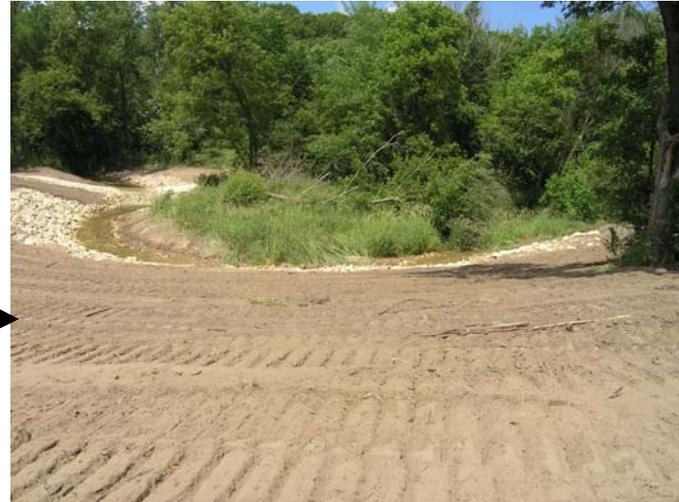
Figure 50. West-streambank site after construction.
